TECHNICAL MEMORANDUM

X-207

MEASUREMENTS OBTAINED DURING THE FIRST LANDING OF
THE NORTH AMERICAN X-15 RESEARCH AIRPLANE

By James M. McKay

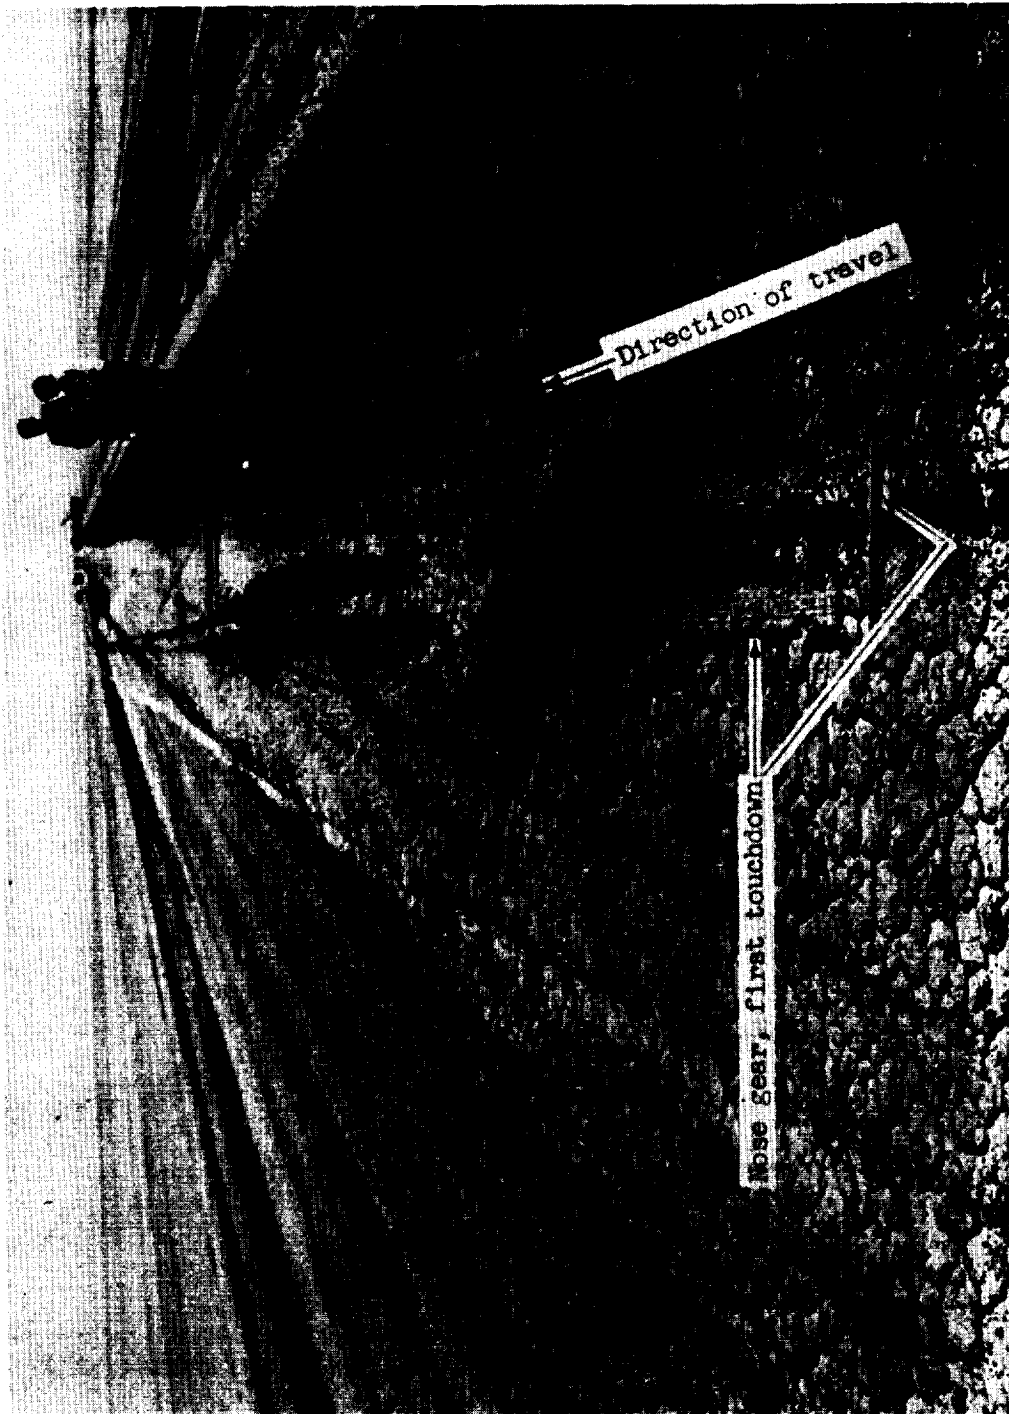
(a) In direction of travel.

Figure 13.- Nose-gear touchdown initial skid marks.

The airplane first contacted the lakebed on the left main skid as shown in figure 12 and table II. The second and final touchdown of the left main skid was made 15 feet down the runway from the initial skid mark. The right main skid first contacted the lakebed 24.6 feet down the runway from the initial left main-skid touchdown point. The right main skid then contacted and remained on the lakebed 37 feet down the runway from the initial left main-skid mark. The nose-gear touchdown occurred 0.52 second later at a vertical velocity of approximately 13.5 feet per second at a point 187 feet down the runway from the left main-gear initial skid mark. A closeup view of the nose-gear touchdown marks is shown in figure 13(a), and a diagram of the skid marks is shown in figure 13(b).

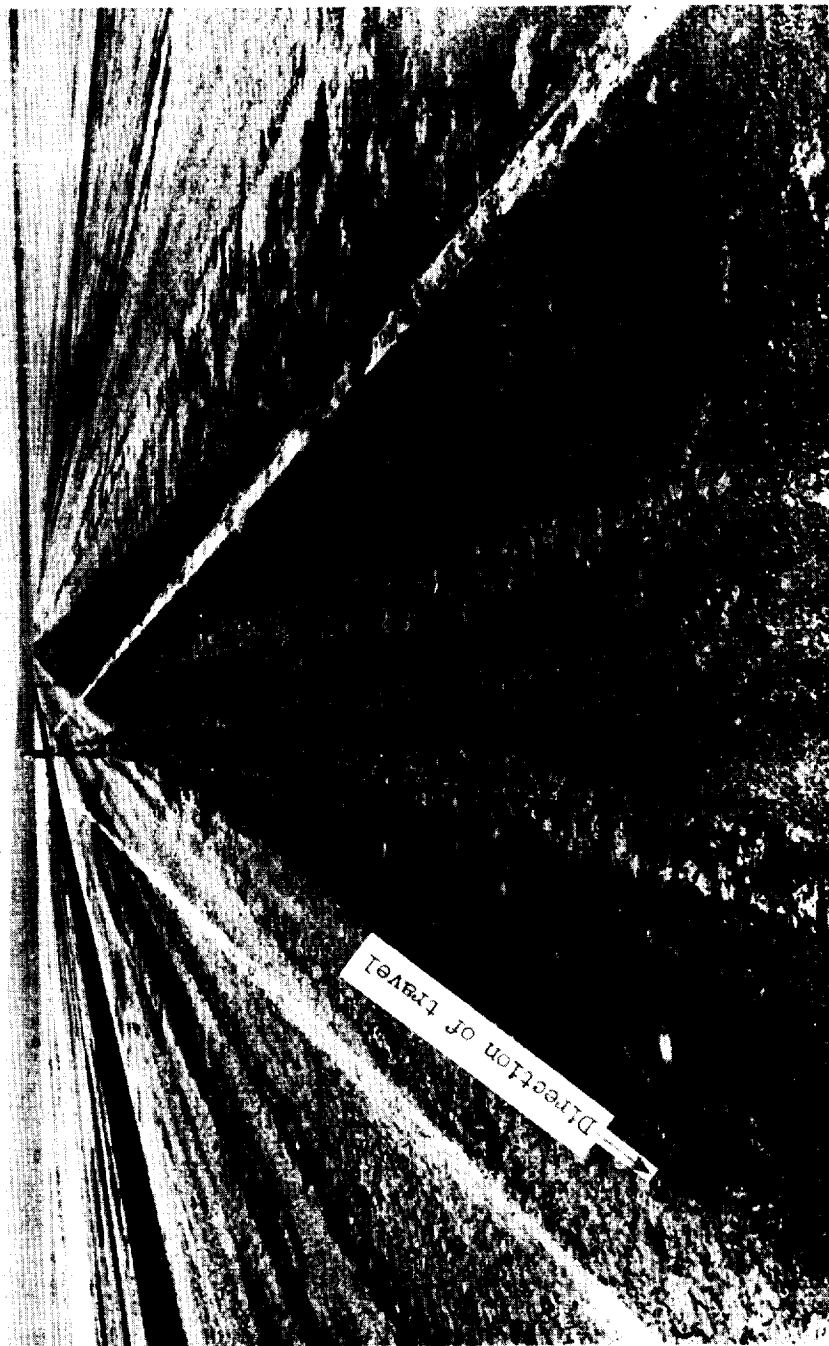
E-4667
(a) Approximately 300 feet from touchdown, looking rearward.

Figure 14.- Main- and nose-gear skid marks.

Photographs of the main-gear skids and nosewheel marks on the lakebed are shown in figure 14(a) for a distance of approximately 300 feet from touchdown and in figure 14(b) toward the end of the landing run.
